HEAD WORKS DAM —
OSSIPPEE LAKE
NH 00328

BERRY BAY DAM —
OSSIPPEE LAKE
NH 00329

PHASE I INSPECTION REPORT
NATIONAL DAM INSPECTION PROGRAM

DEPARTMENT OF THE ARMY
NEW ENGLAND DIVISION, CORPS OF ENGINEERS
WALTHAM, MASS. 02154

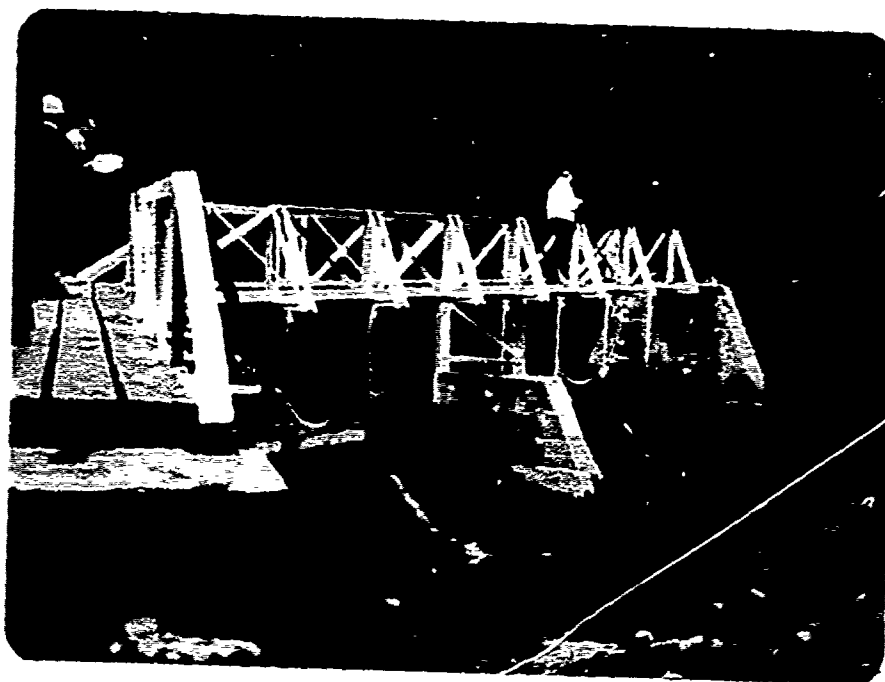
Berry Bay Dam - Overview from right
abutment

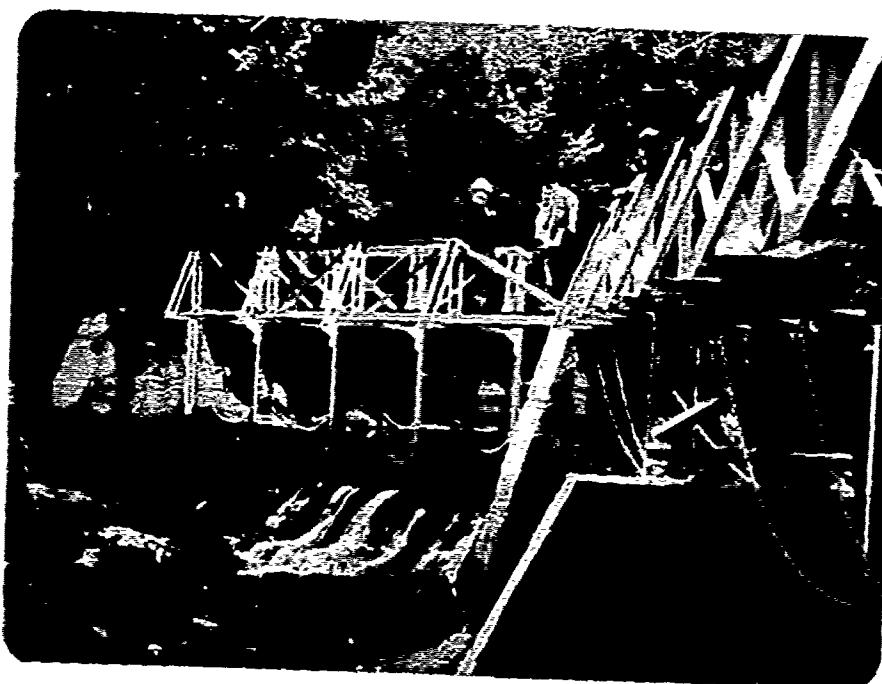
Berry Bay Dam - Overview from left
abutment

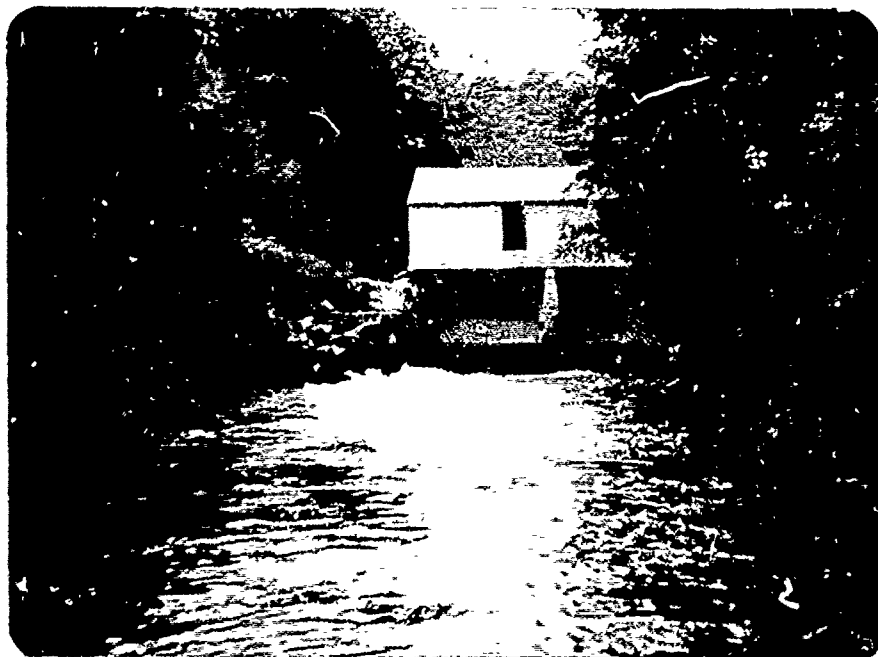
Head Works Dam - Overview from
downstream
